# Building Inspection Report

**1800 N. Douglas Road, Hollywood, Florida**

**Inspection Date:**  
October 16, 2008

**Report Number:**  
7727

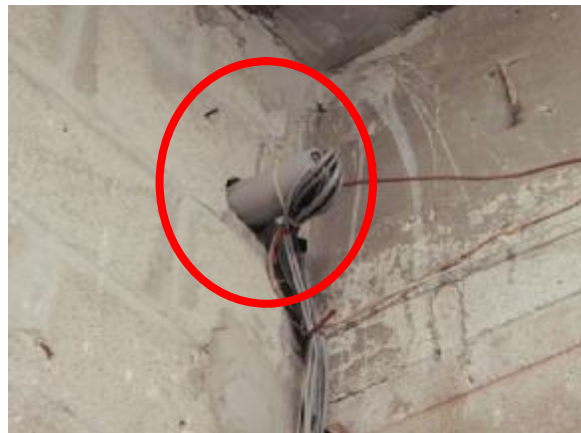
The conduit penetration requires fire stop caulking.

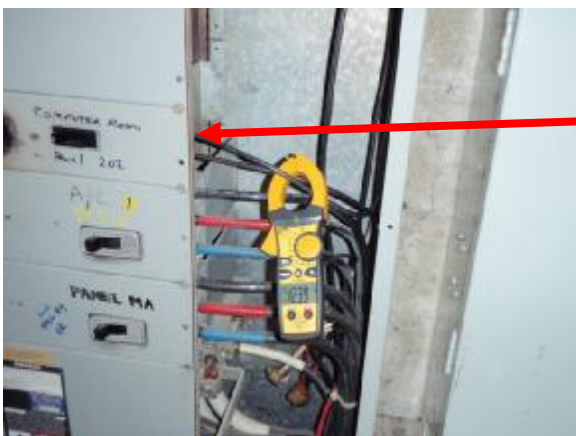
- **Repair:** This panel's feed lines are overheated and require repair.

This leg is unbalanced and extremely overheated.

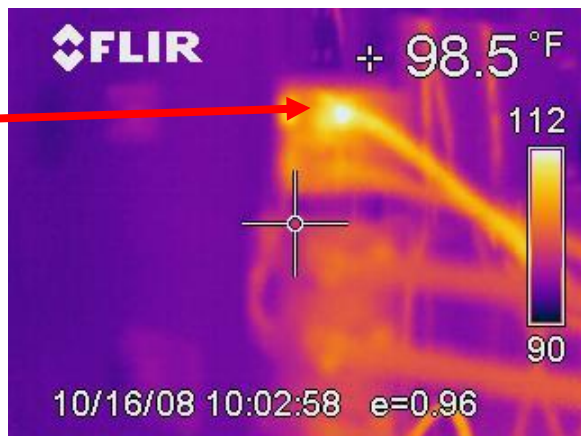
The white and yellow represent hot temperatures.

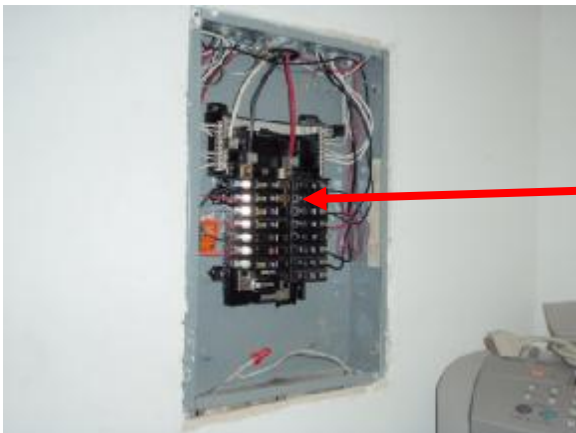
- **Repair:** The panel is completely overheated including the bus bars and replacement is required.

This panel is all overheated and needs replacement.

Budget \$3,500 / \$5,000 or more for repairs/replacement, depending on conclusions and approach.

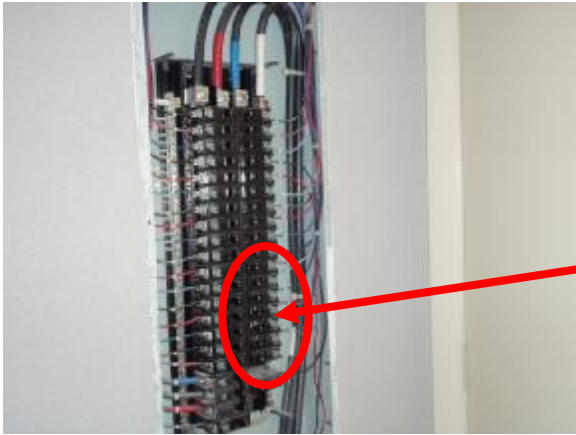
Another panel with indications of overheating.

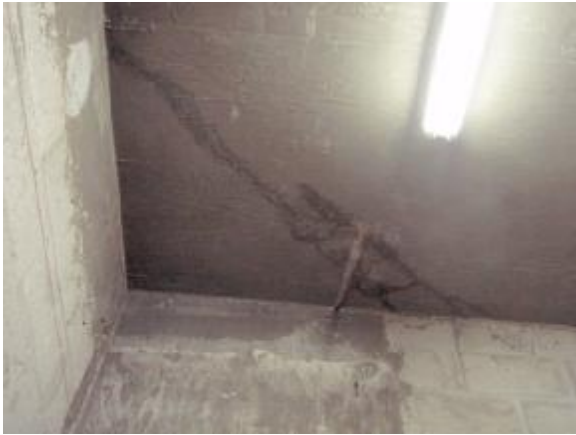
- **Repair:** This structure is not water proofed and signs of leaks were present in the electric room. It has been recently pressure washed. Water proofing this surface and re-caulking the wall/roof connections would be prudent now, the most likely source of leaks.
- **Repair:** The edging is damaged and the synthetic stucco material is exposed to water intrusion. (see photo section of this report)

The roof leak at the main panel room.

Budget \$2,800 or more for repairs, depending on conclusions and approach.

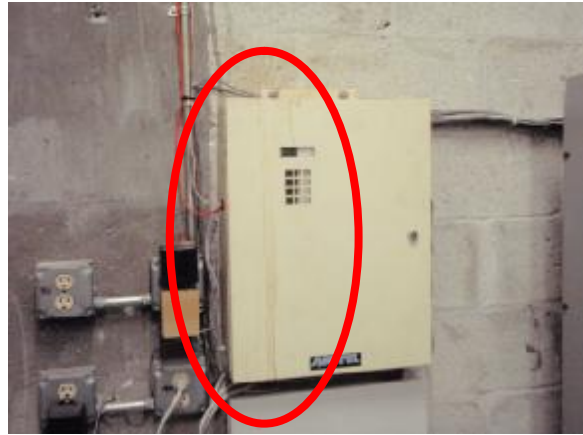
Drip stains from the leak.

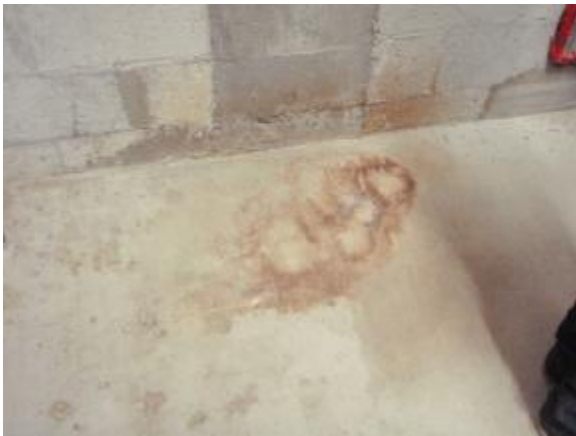
And on the floor

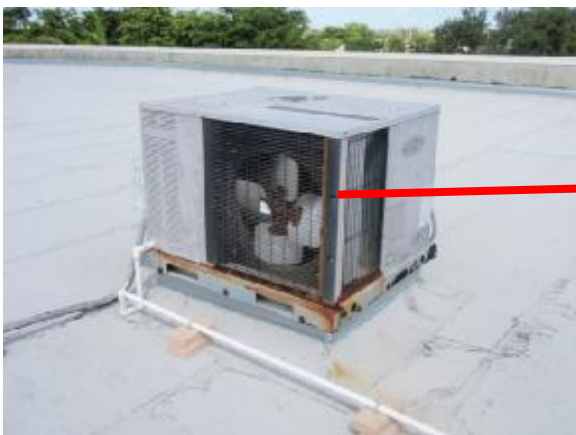
As units 1, 2, and 7 are older, they will require repairs or replacement soon. **Budget for replacement accordingly.**

View of the older a/c's

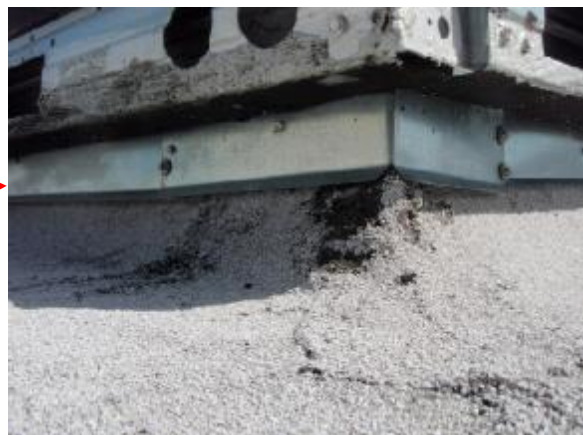
The well flashed curbs.

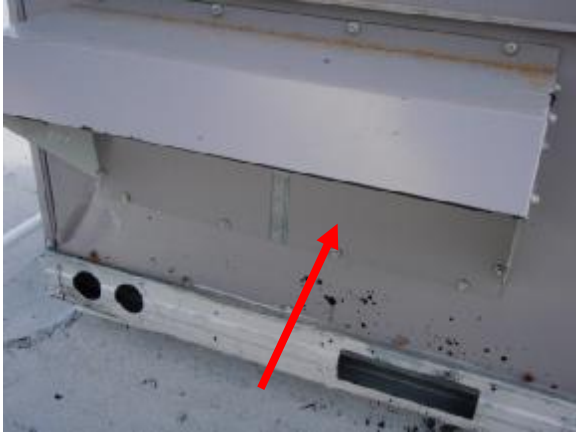
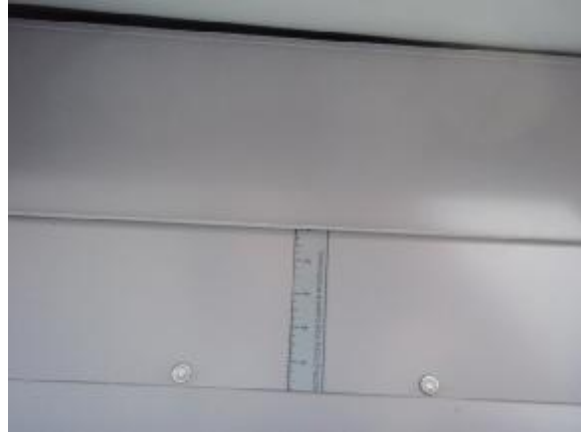
- **Repair:** The fresh air intakes are not open.

The fresh air intakes should be open.

Budget \$150 **or more** for repairs, depending on conclusions and approach.

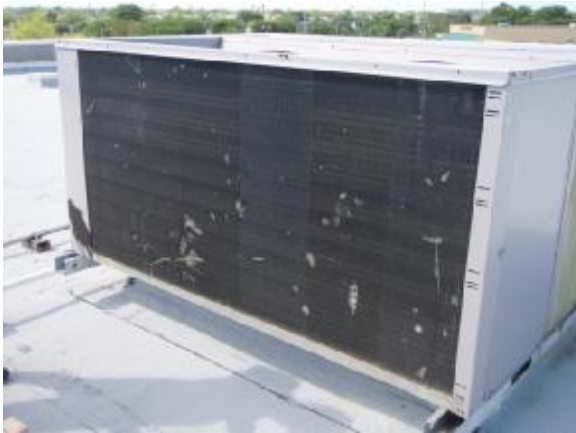
The damaged coils

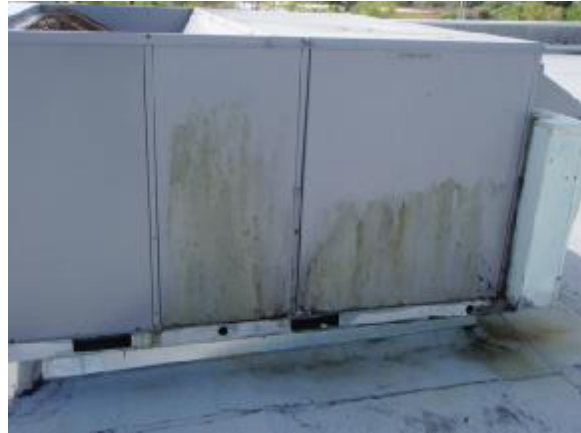
Signs of previous leaks.

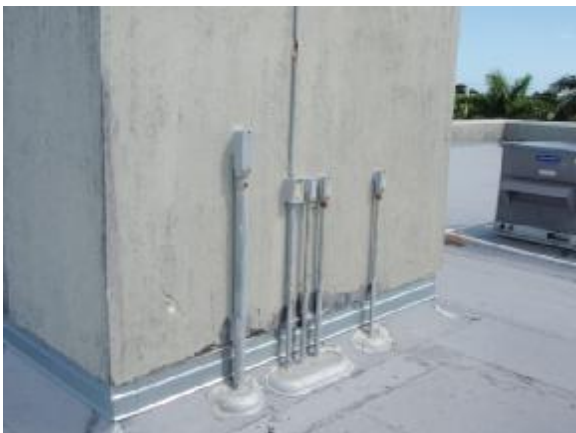
View of the proper flashing.

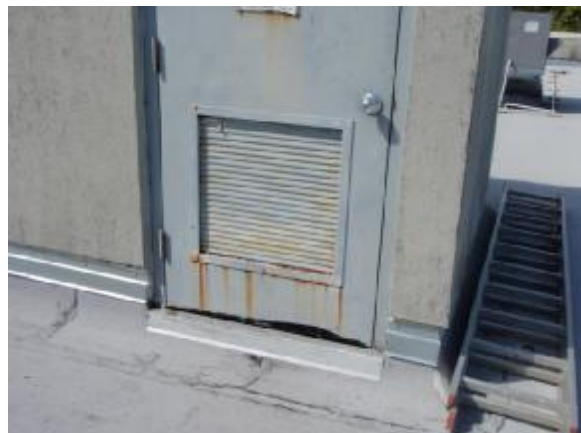
- **Repair:** The elevator room door is quite rusted out and it appears water may be intruding to the inside. *This room was not accessible today.*

The rusted and damaged elevator room door.

Budget \$500 ***or more*** for repairs/replacement, depending on *conclusions and approach.*

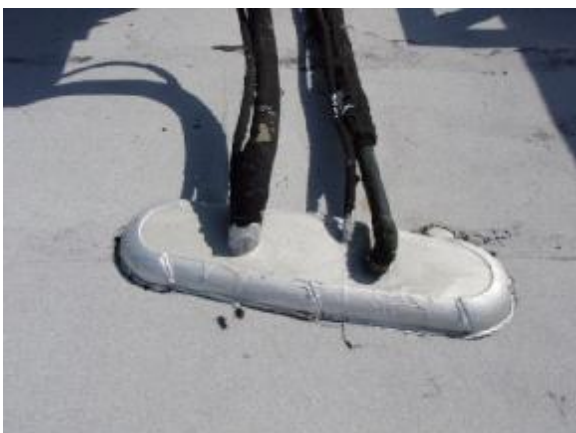
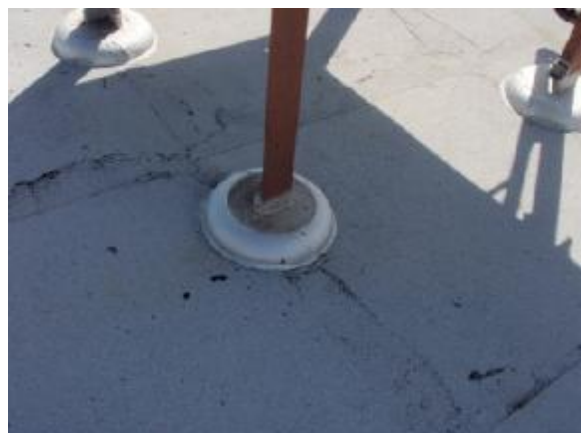
Well flashed roof penetrations
