# Building Inspection Report

**6550 SW 51 Terrace, Miami, Florida**

**Inspection Date:**  
February 10, 2009

**Report Number:**  
7879

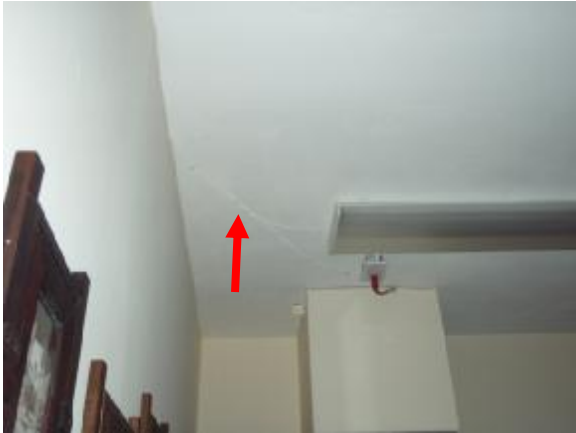
The Romex wire is installed improperly

- **Repair:** Extension cords should not be used as permanent wiring at the disposer. This wiring should be removed and the fixture properly wired.
- **Repair:** A rigid conduit should protect wiring exposed in the converted garage ceiling.

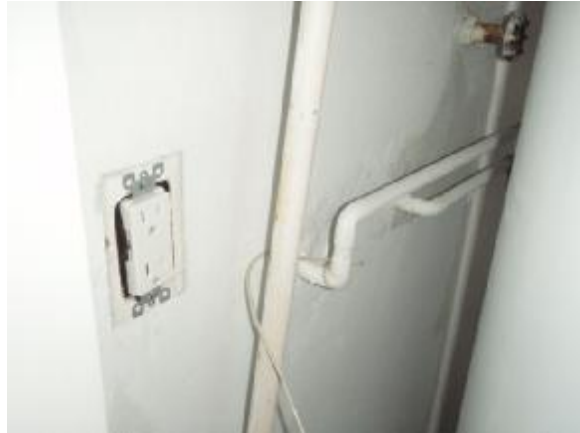
Replace outlet covers

- **Repair:** Missing outlet cover plates should be replaced to avoid a shock hazard.

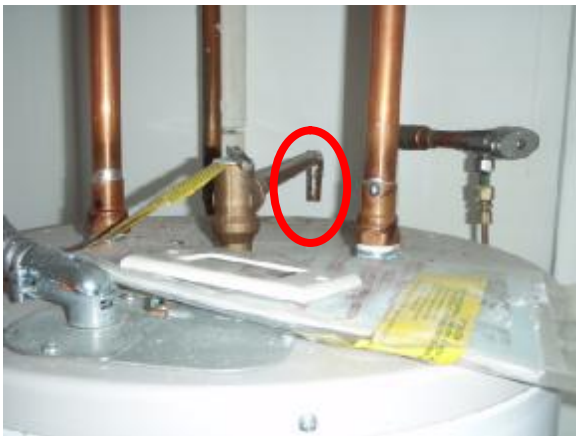
The TPR pipe requires repair

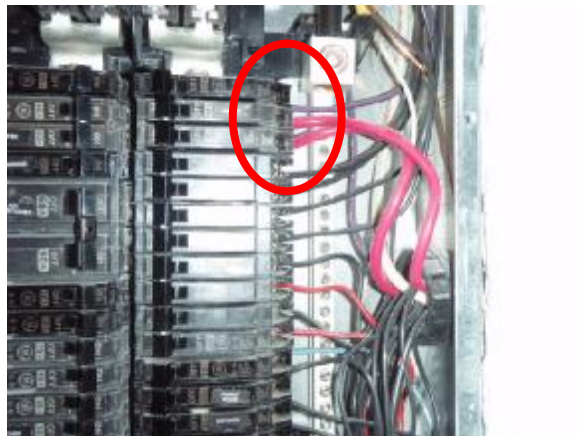
The 30 amp breaker's wire is not sized properly.

- **Notice:** The auxiliary electrical panel is mostly arranged well and most breakers are properly sized.
- **Repair:** The upper right 30 amp breaker is not wired with the proper sized wire.
- **Improve, Safety Issue:** Some or all of the screws used for the panel cover are missing. Non-pointed screws should be used to secure the panel properly.
- **Repair:** Improper splices within the panel should be improved.
- **Repair:** Improper Romex wires are noted inside the panel. These wires should be cut back and removed from inside the panel.
- **Repair:** Any openings in the auxiliary panel should be covered.

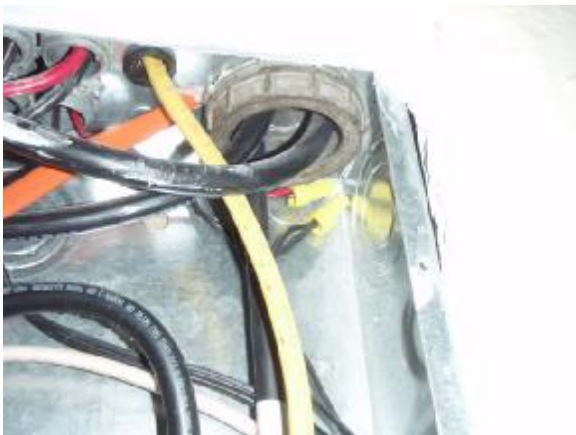
The Romex wires are improper in the panel.

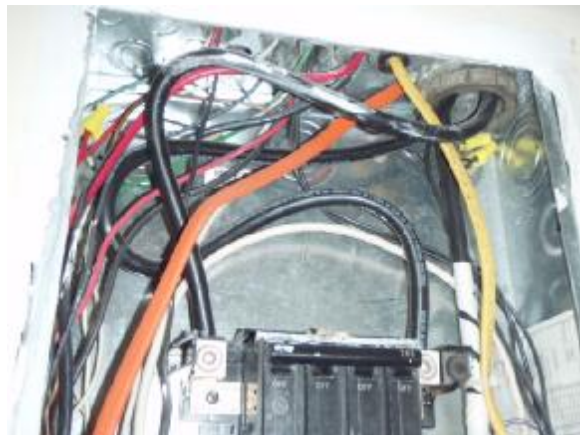
Splices in the panel need correcting.

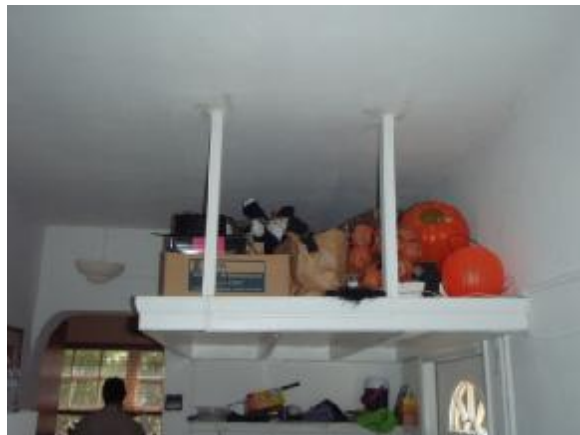
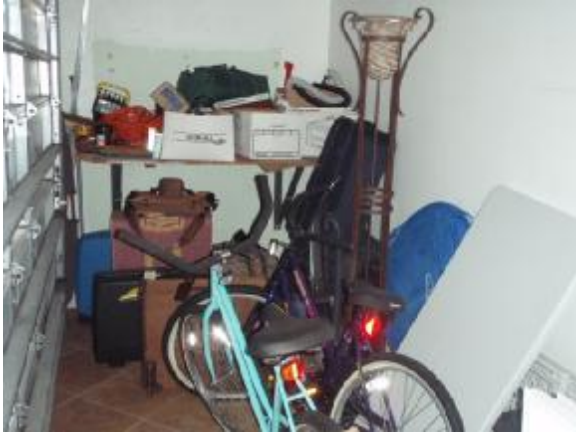
Stored items restricted

same

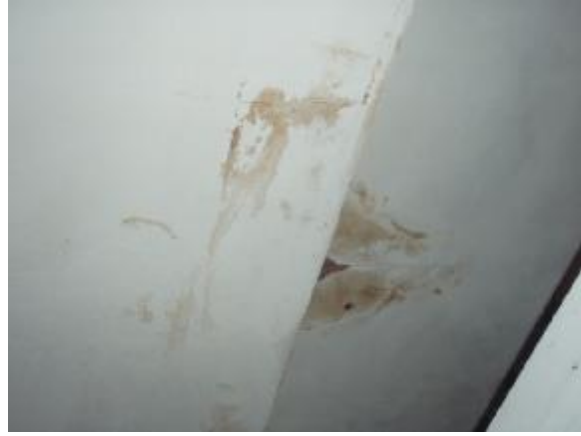
- The roof coverings are in generally good condition.
- **Notice:** Water staining was observed in the garage ceilings. It could not be determined if the stain is new or old. Ask the seller to disclose any leak history. Investigate further during the next rain storm.

The garage stains

- **Monitor:** Typical cracks were noted throughout the interiors.
- **Notice:** Water staining was observed in the garage ceilings. It could not be determined if the stain is new or old. Ask the seller to disclose any leak history. Investigate further.

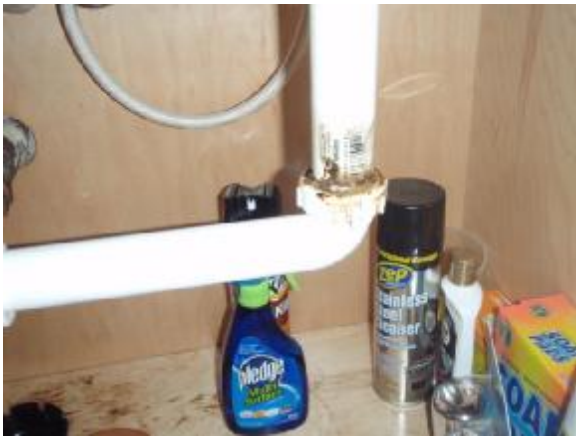
Tighten the sink trap

- **Repair:** The trap on the waste line under the kitchen sink is leaking slightly. Tighten further.

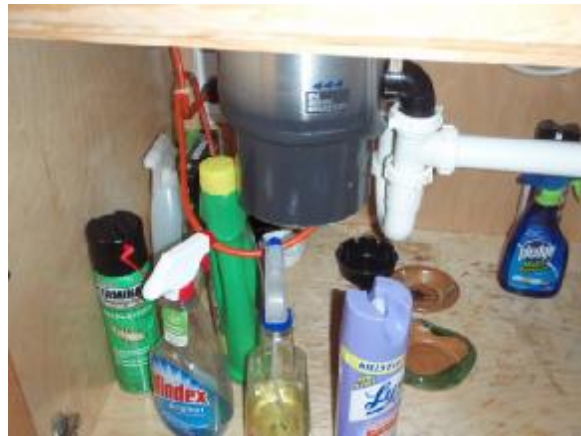
- **Safety Issue, Repair:** The wiring leading to the waste disposer is not the proper type. The wiring leading to the waste disposer should be protected by a rigid conduit.

The disposer is not wired safely

Budget \$125 / \$175 *or more* for repairs, depending on *conclusions and approach*.  
*Consult a licensed electrician, before closing, for remedies and exact estimates.*

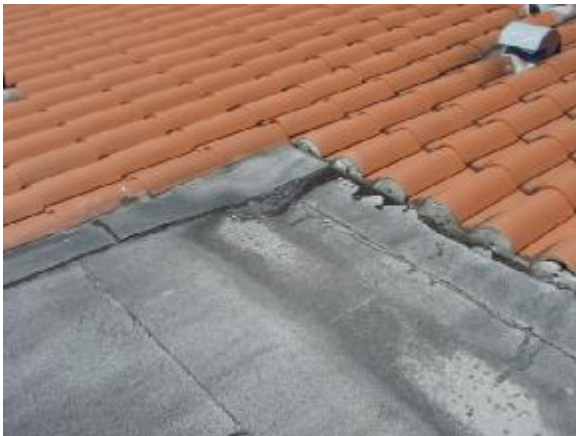
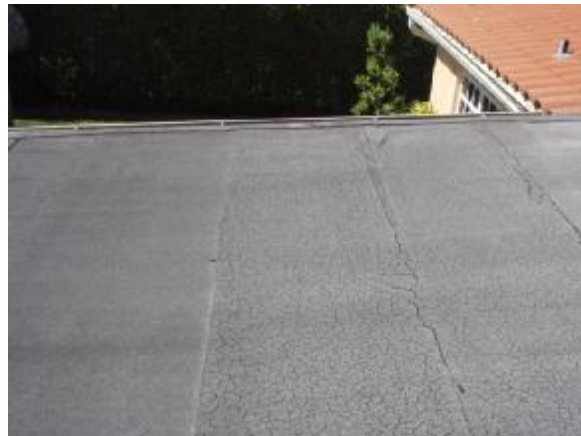
- **Repair:** The roofing is near the end of its useful life. The membrane exhibits flaws (such as blistering, cracking, loss of granules and ponding water) that are symptomatic of an old flat roof. You should expect to replace it soon. Repair the blister now.

The flat roof is deteriorated.

....and worn

Budget \$500 or more for repairs, depending on conclusions and approach.  
Consult a licensed roofer, before closing, for remedies and exact estimates.

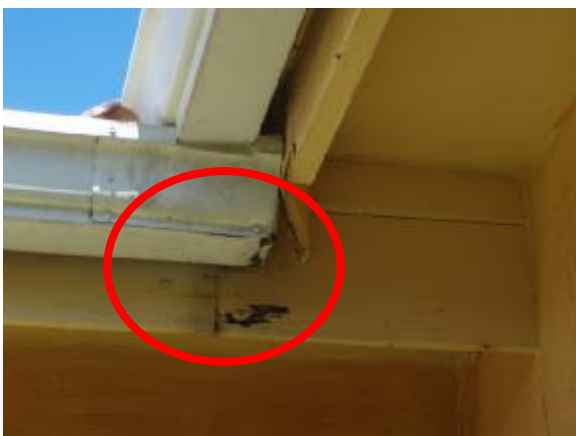
- **Repair:** Localized water damage was observed in the fascia and / or soffit at one or more locations. Improvement is prudent, although this condition could be repaired when exterior painting or maintenance are planned.

The water damaged wood.

Budget \$125 / \$175 **or more** for repairs, depending on *conclusions and approach*.  
**Consult a licensed contractor, before closing, for remedies and exact estimates.**

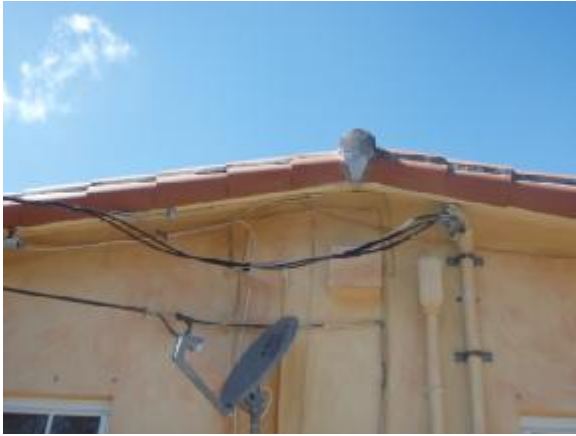
The service wires should be improved.

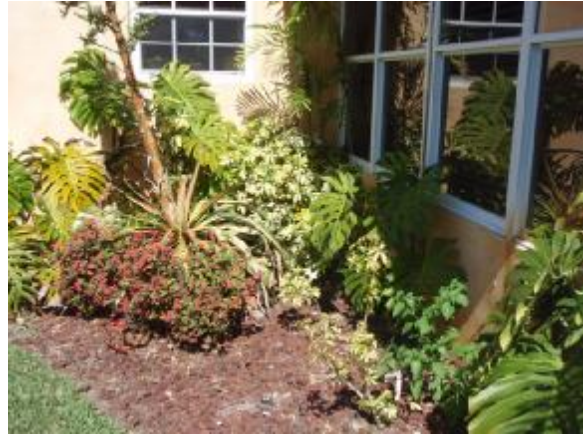
The exterior landscape restricts the inspection.
