Building Inspection Report

801 Brickell Key Boulevard, Unit 1005, Miami, Florida

October 7, 2008

7711

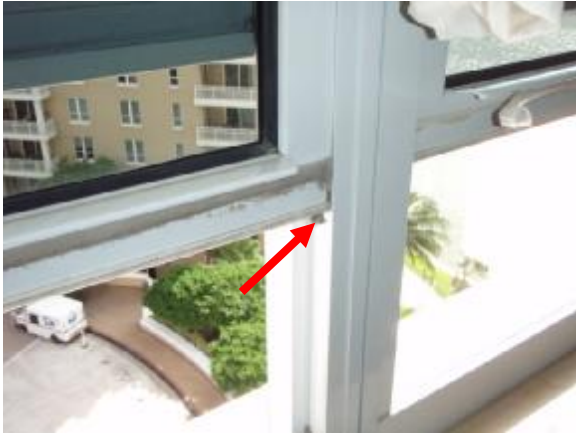
- **Repair:** The LEFT window spring is damaged. At least 1 window was in this condition. Locate all of the windows in this condition and repair as necessary.

Damaged window spring.

Budget \$75 / \$125 *or more* for repairs, depending on *conclusions and approach*.

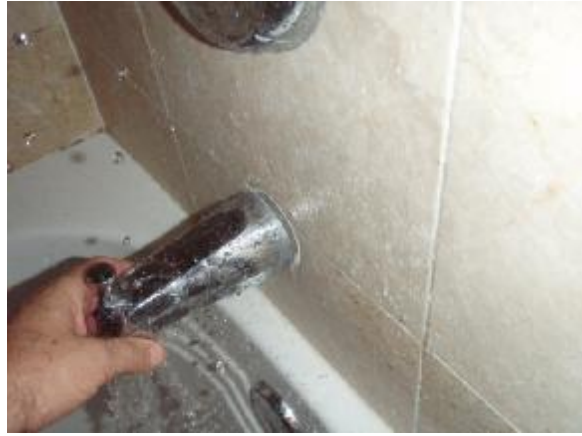
- **Repair:** The shower diverter did not operate properly.
- **Repair:** The tub spout is loose and requires caulk. (see photo section of this report)

Tub spout loose.

Budget \$125 / \$175 **or more** for repairs, depending on *conclusions and approach*.

Consult a licensed plumber, before closing, for remedies and exact estimates.

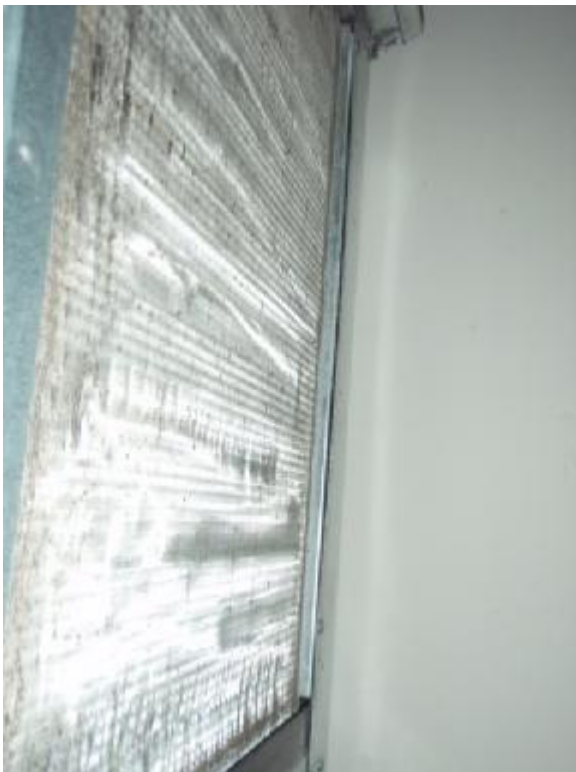
- **Repair:** The fins of the evaporator coil were observed and are significantly damaged. Consult a licensed A/C contractor, before closing, for remedies and exact estimates.

The damaged a/c coil.

Budget \$500 / \$700 or more for replacement, depending on conclusions and approach.
Consult a licensed A/C contractor, before closing, for remedies and exact estimates.

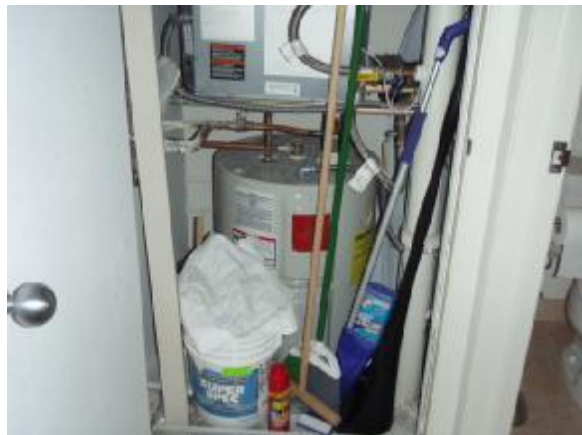
The a/c closet should be clean and not used as storage

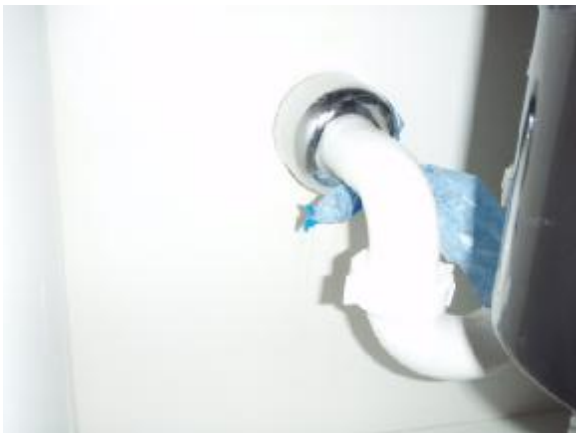
- **Repair:** The waste line under the kitchen sink is taped and slightly leaking. Ask the seller to disclose any leak history. Evaluate further.

The trap below the kitchen is taped and drips water.

Budget \$125 / \$175 *or more* for repairs, depending on *conclusions and approach*.

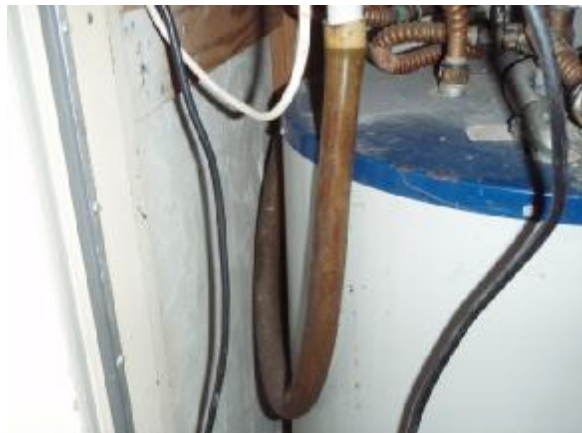
The a/c condensate line is clogged.
